Woodstock 177/148 – NH 175 over the Pemigewasset River

Woodstock 27713

NH 175 over Pemigewasset River

Woodstock Select Board Meeting

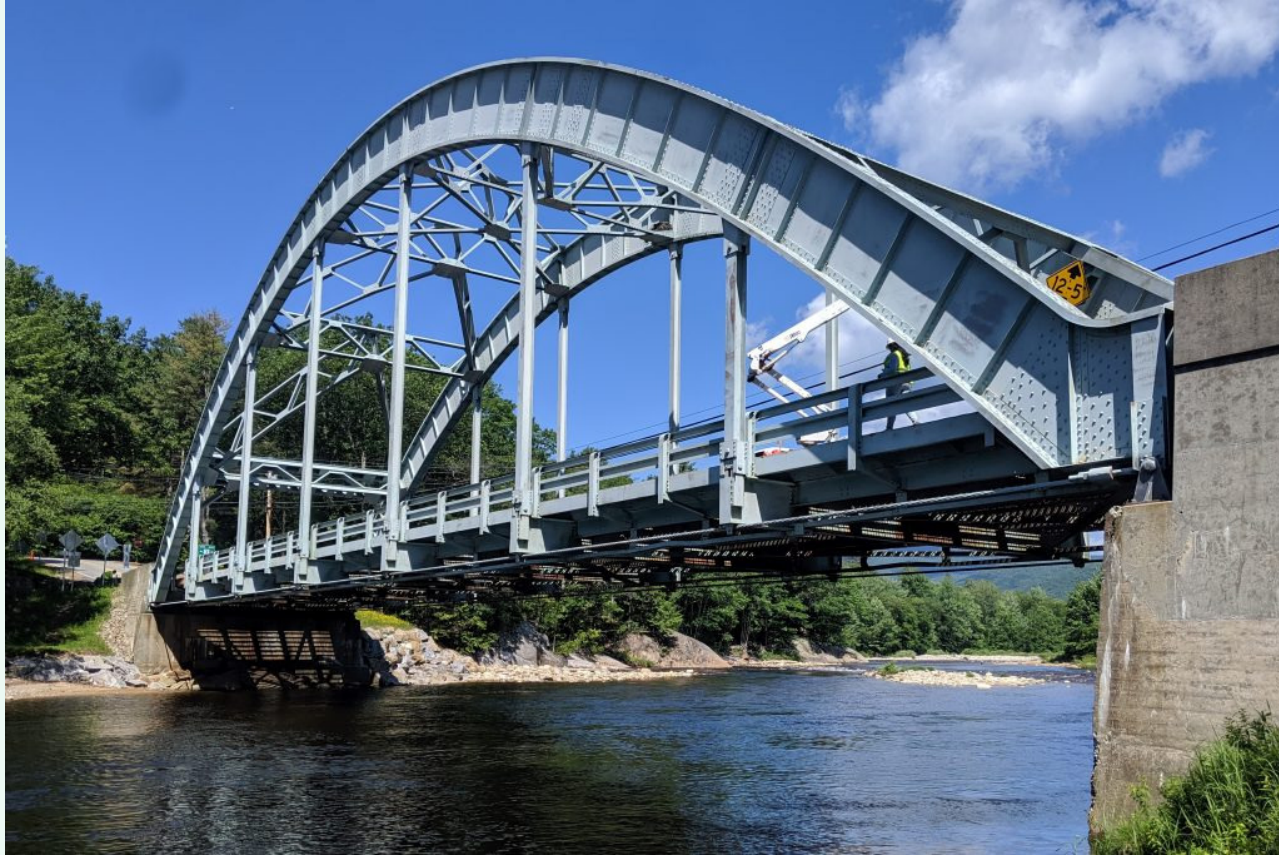
Existing Bridge

- Built 1939
- 183' Long Steel Tied Arch with an Open Grid Deck
- Red-Listed in 2014 – Posted 20 tons
- Currently rated Deck 4, Superstructure 4, Substructure 5

- Grid deck replacement has been ongoing since 2010
- Over 40% of the deck has been replaced or plated
- Over \$350,000 has been spent since 2010
- Additional work is now needed

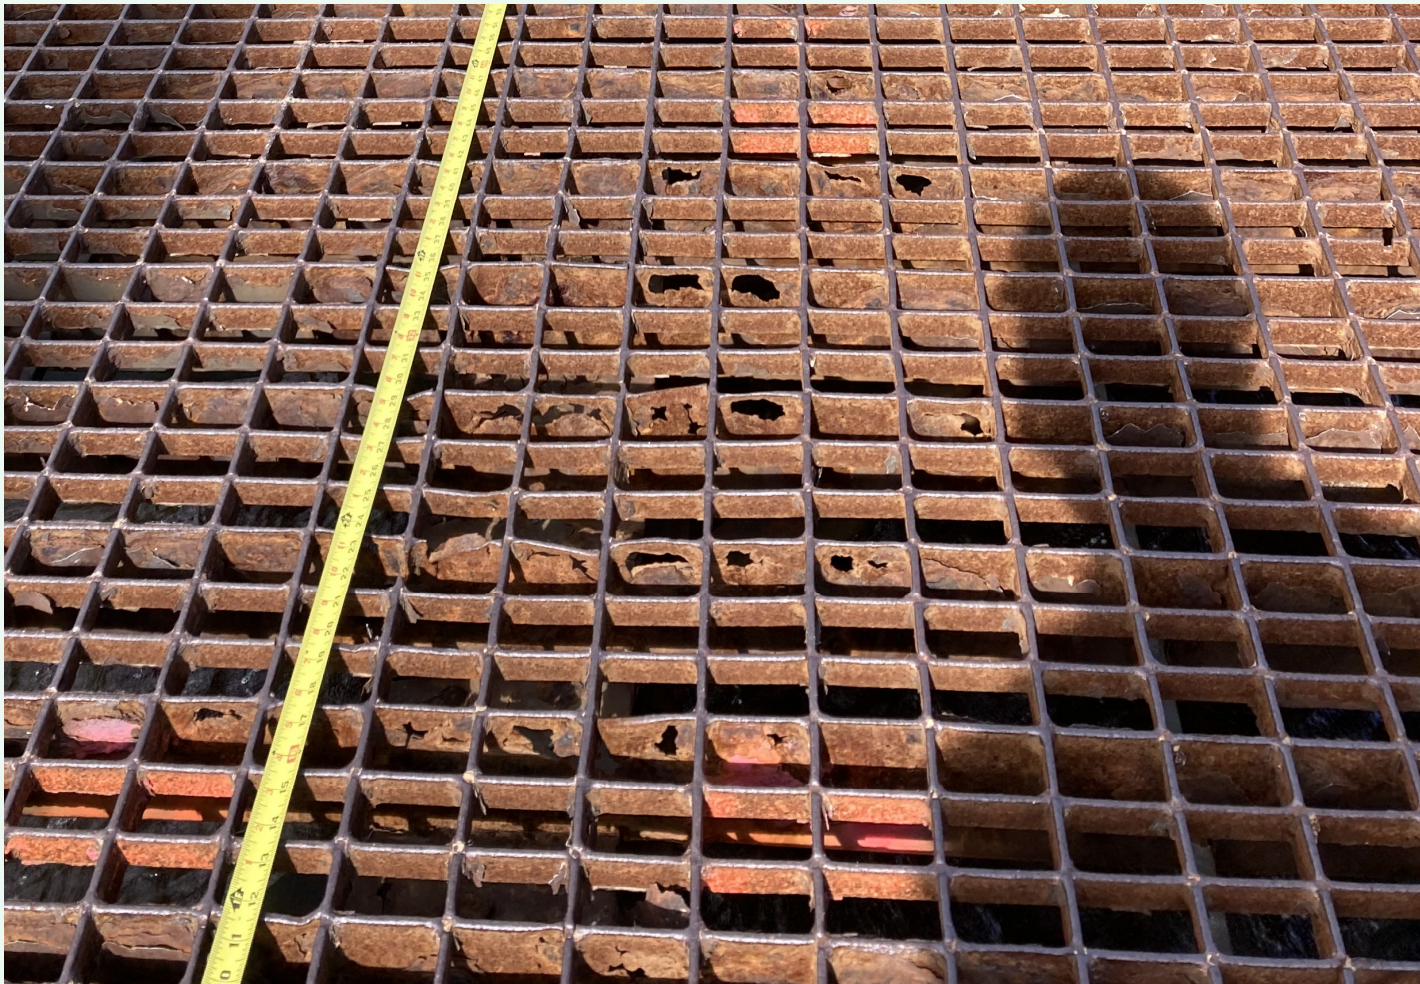
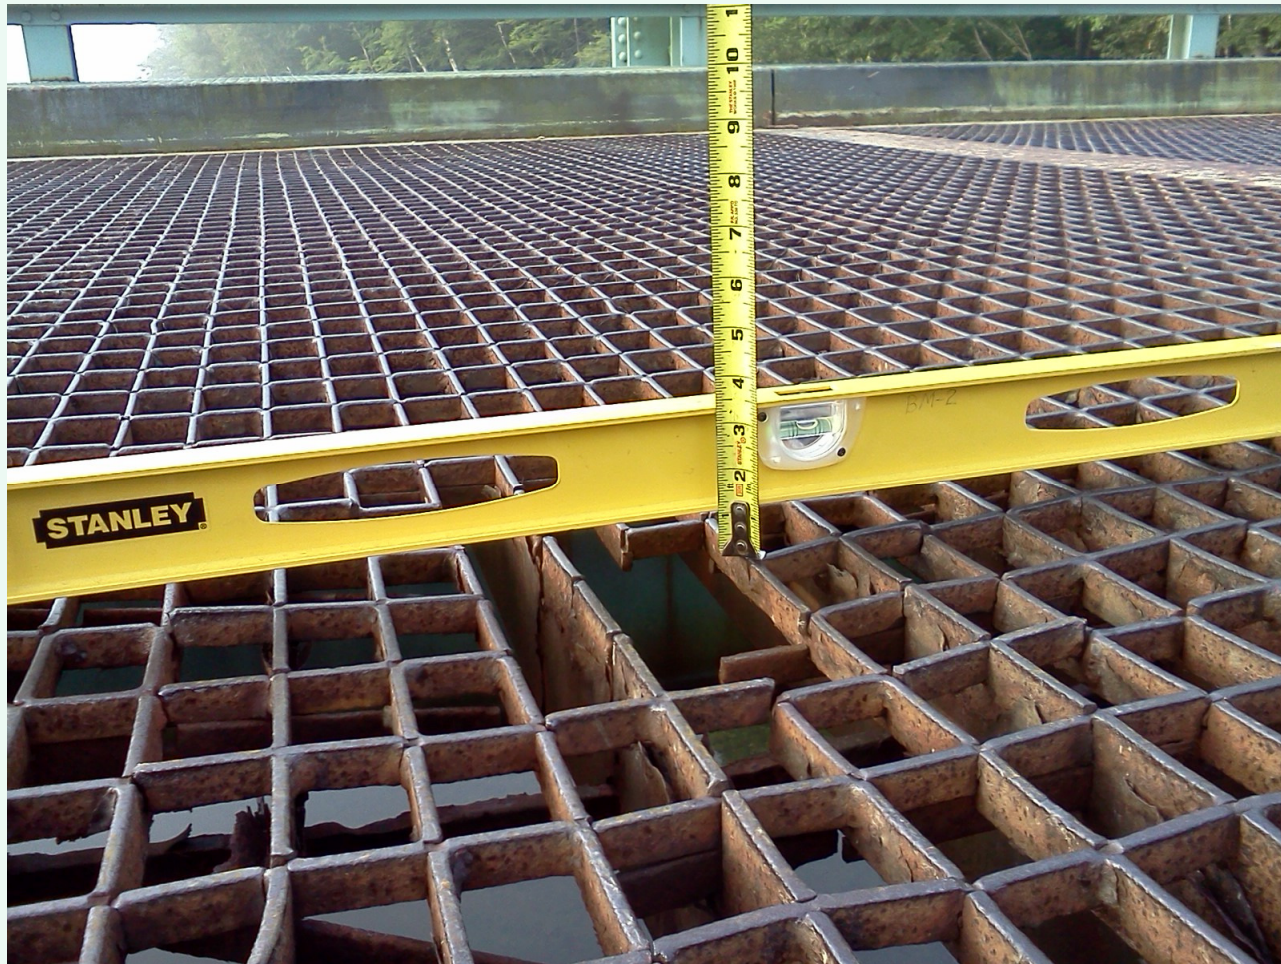
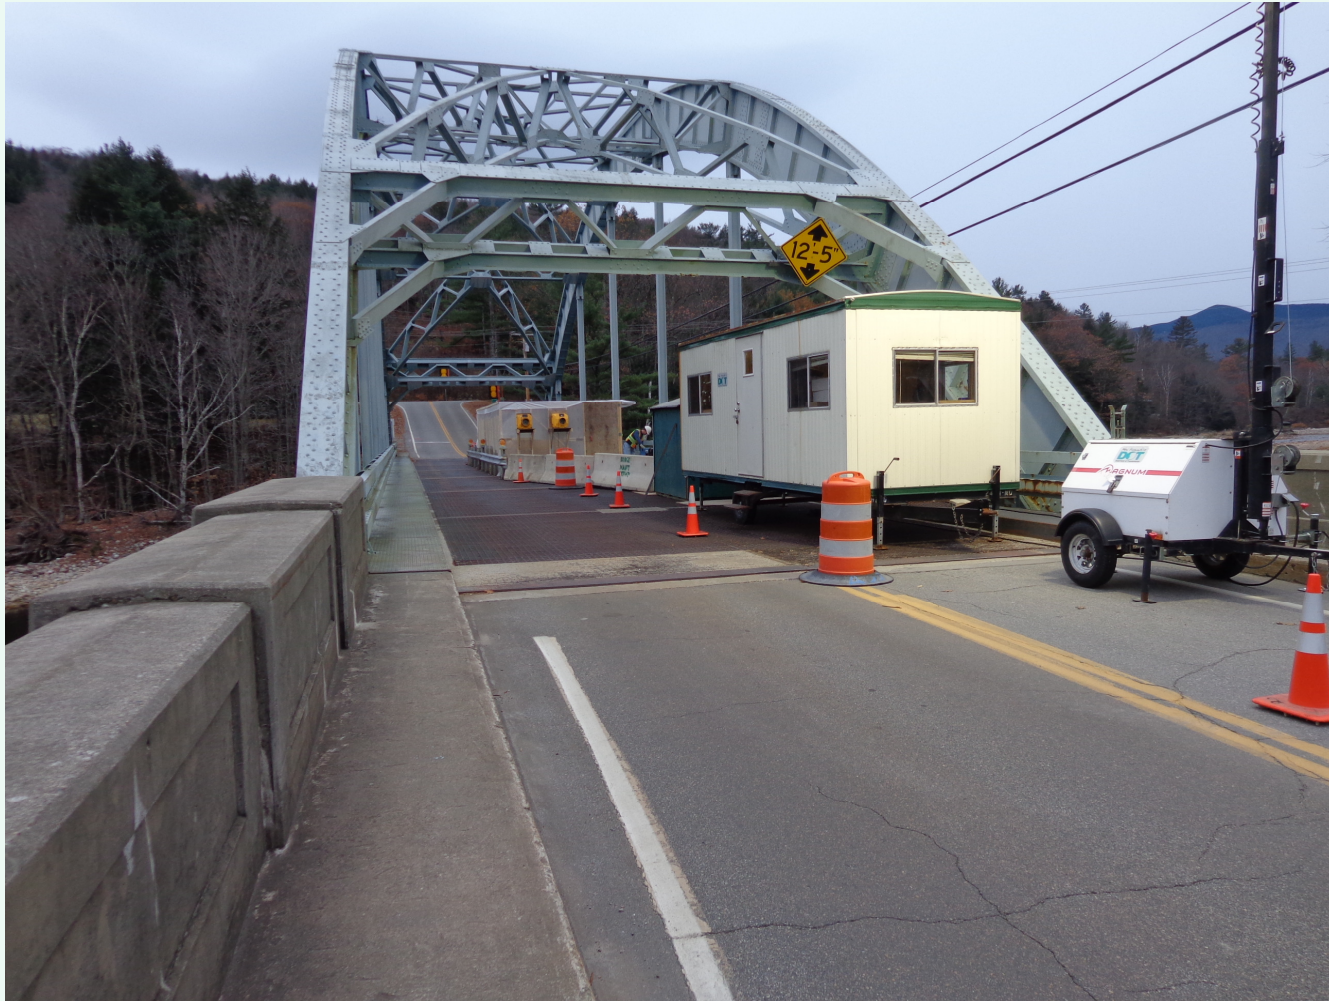
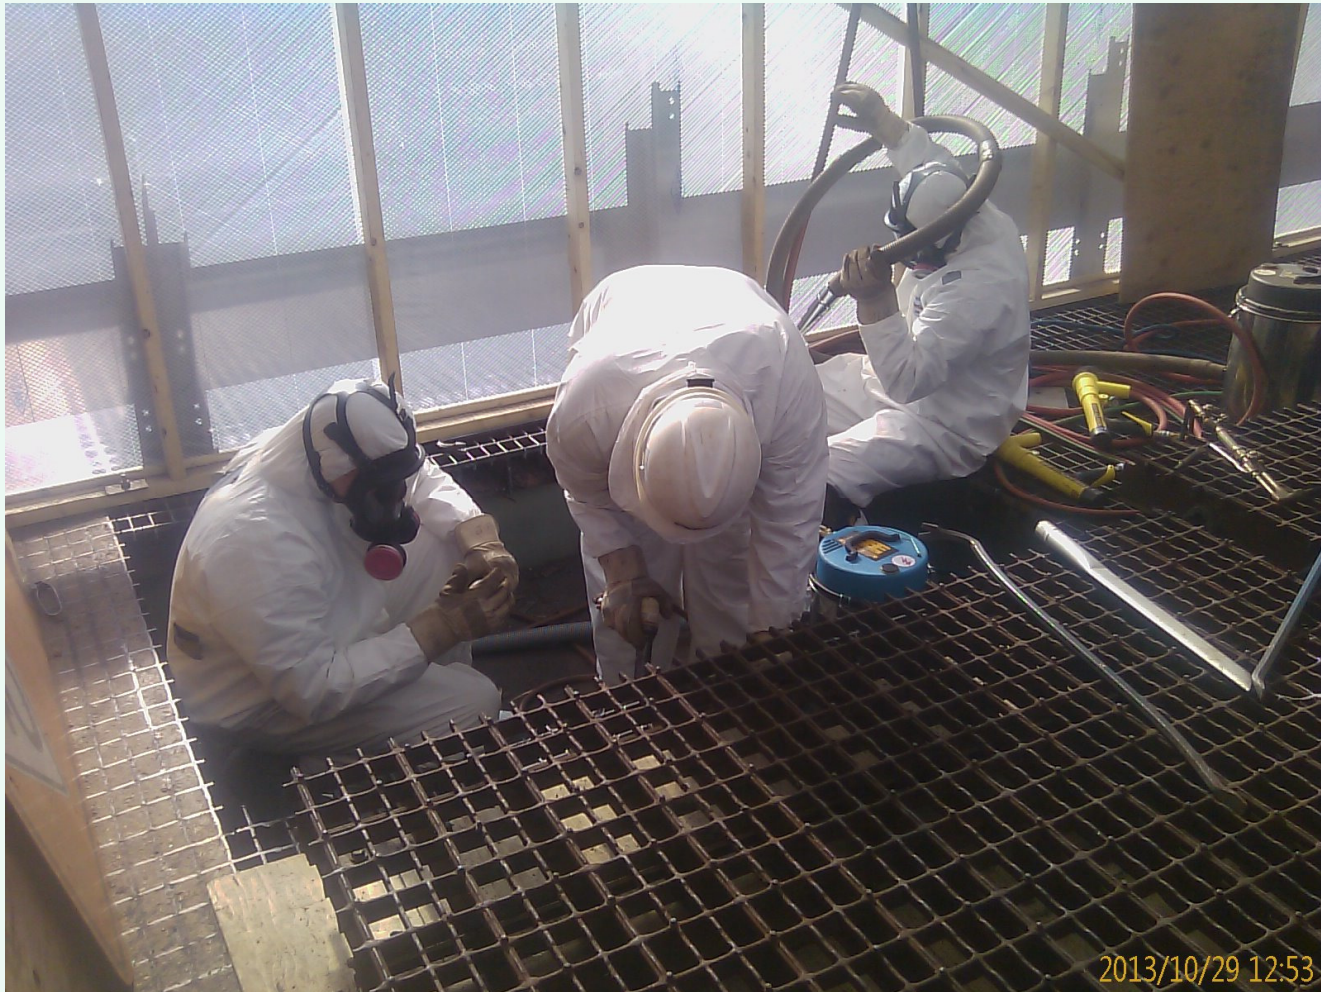
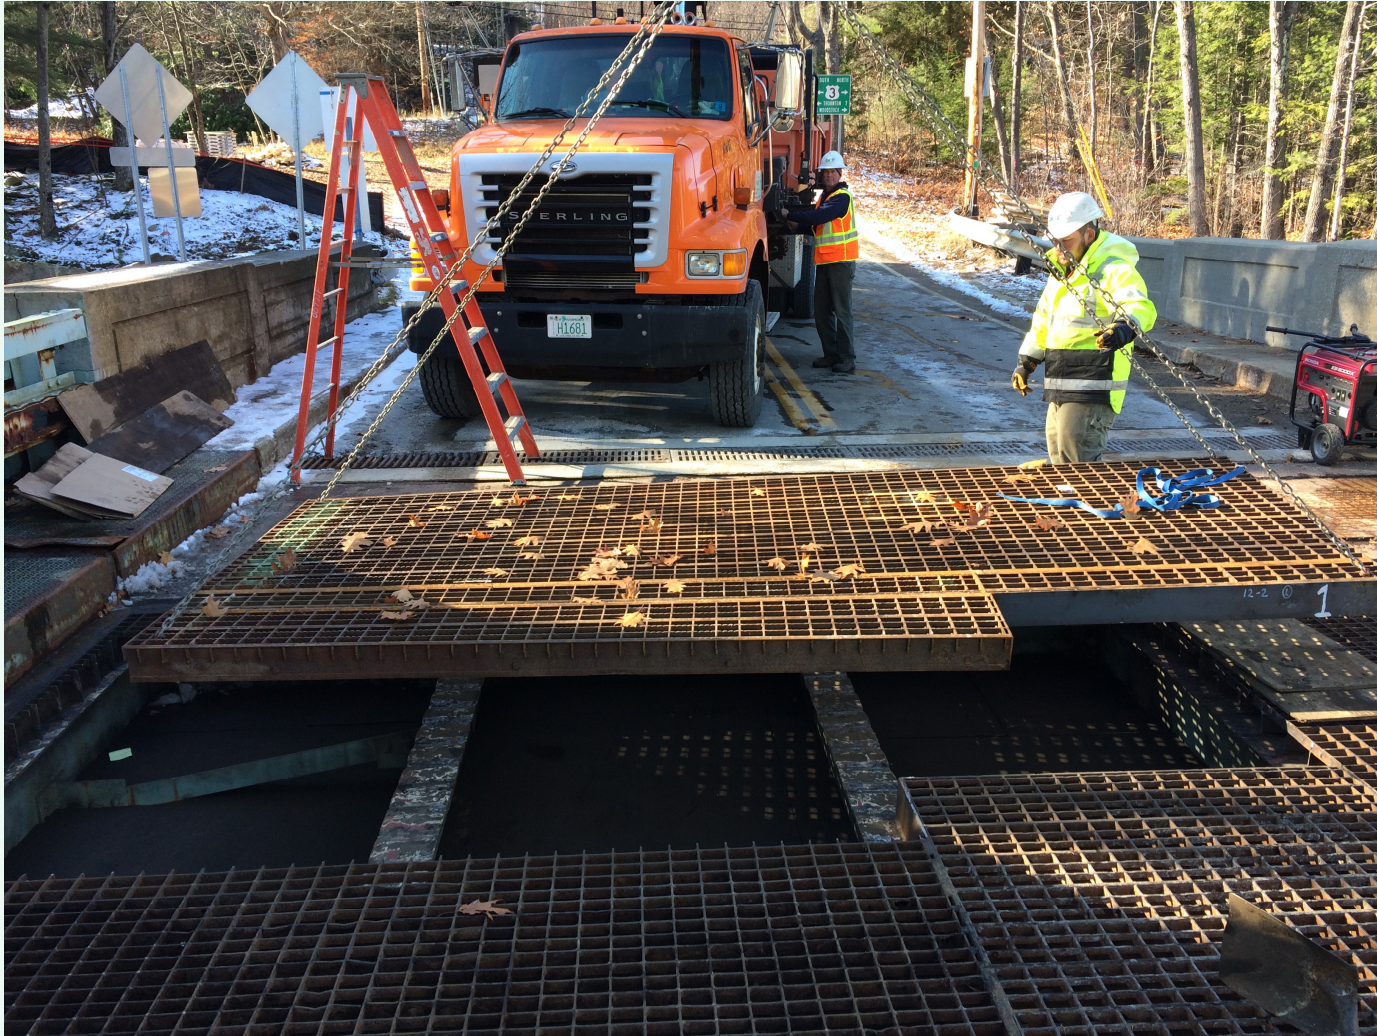
The Department has been working to keep this bridge open to most vehicles since 2010

The bridge load posting was reduced in 20 tons in 2019.

The deterioration of the open grid steel grading is accelerating, and we are now at a point where we need to restrict traffic to a single lane and down post the allowable loading further.

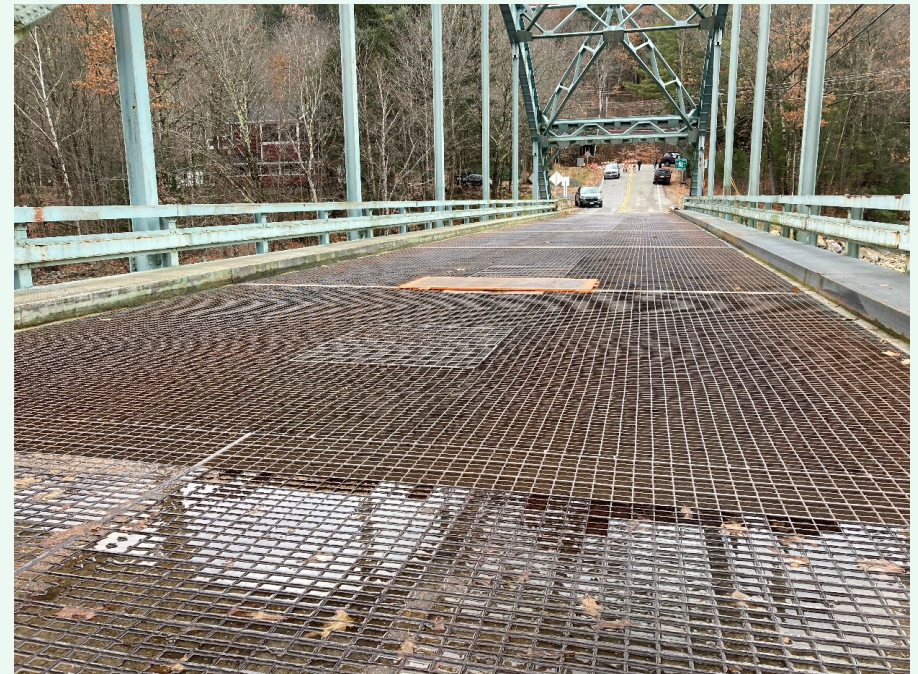
- Tier 3 Roadway
- Approx. 570 vehicles per day
- Roadway Width: 24'-0" curb-to-curb
- Open grid deck has led to deterioration of structure and is hazardous for cyclists

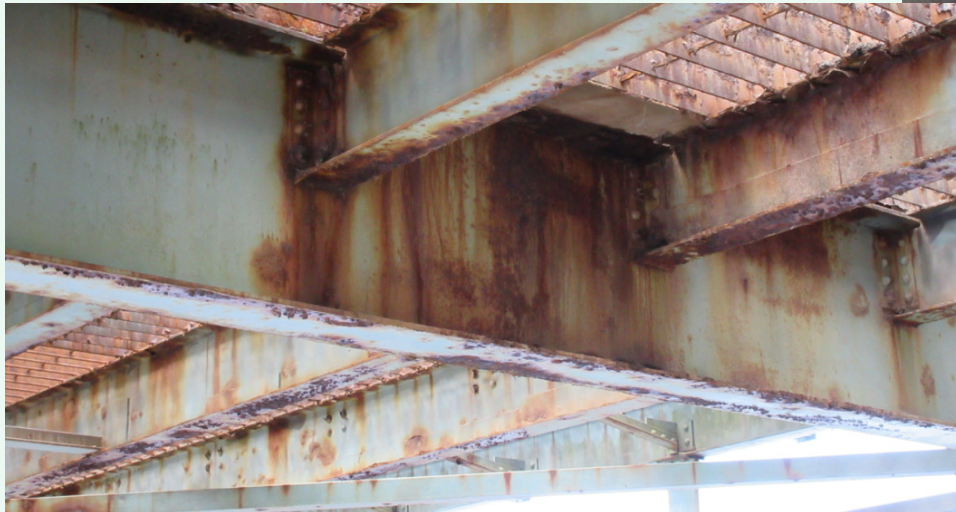
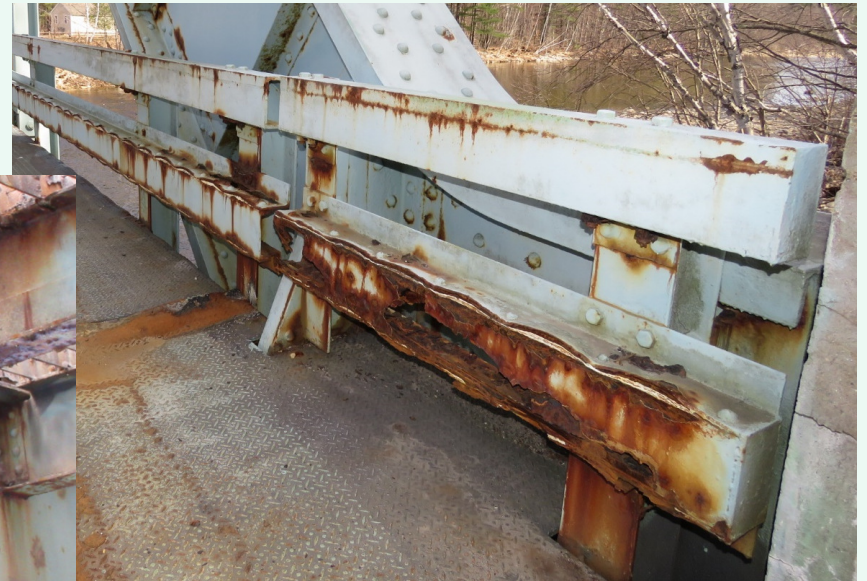
Floorbeams, Stringers, Deck and Bridge Rail

- Load Rating – Inadequate for Legal Loads
- Condition – Heavy Corrosion and Section Loss
- Recommendation – Replacement
- Not Significant Features

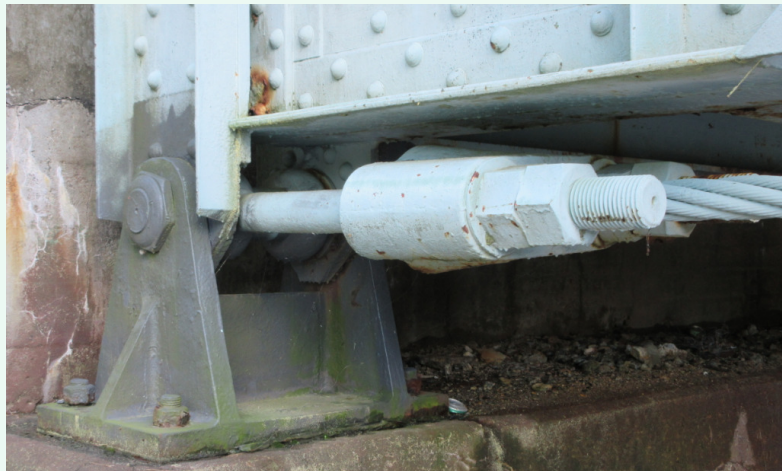
Cable Tie

- Load Rating – Inadequate for Legal Loads
- Condition – Fair, Broken Wires
- Recommendation – Replacement
- Requires a temporary cable
- **Significant Feature**
